4 WHEEL STEERING — REAR WHEEL ALIGNMENT

NO. TSB-92-37B-001

DATE November, 1992

MODEL 91-92 GALANT VR4, 91-93 3000GT VR4

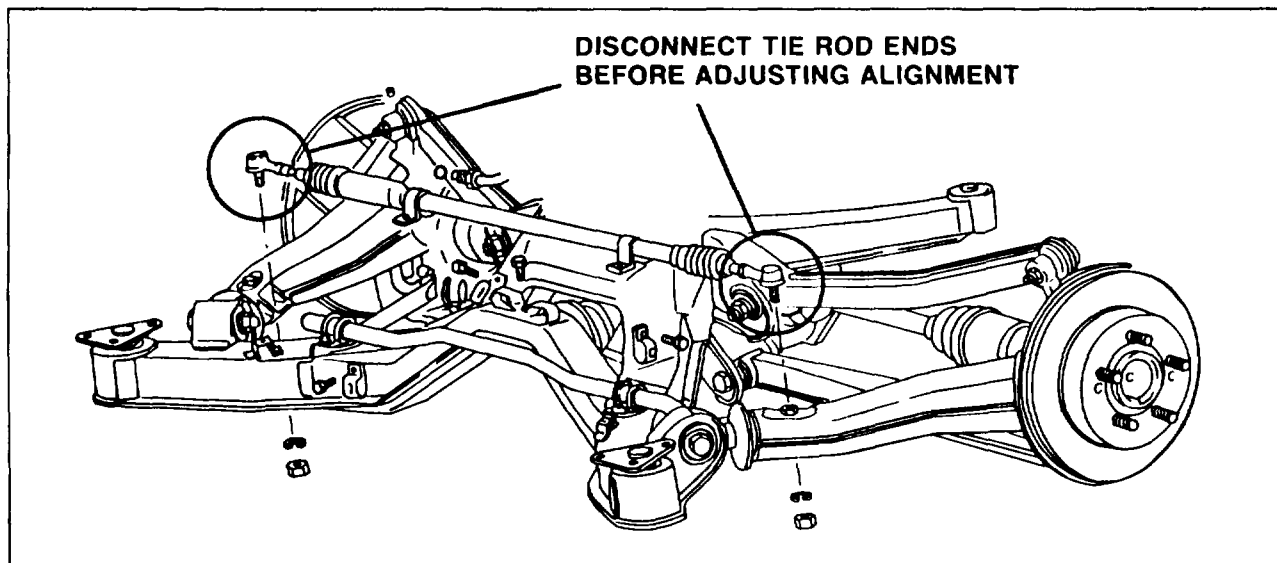
When adjusting camber and toe-in on 3000GT VR4 vehicles you **MUST** first disconnect the 4-wheel steering tie rod ends from the trailing arms. If the tie-rod ends are not disconnected, the 4-wheel steering system will restrict the amount of toe adjustment and alter the alignment angles. Use the following procedure when performing a rear wheel alignment.

CAUTION: Failure to disconnect 4-wheel steering tie rod ends before adjustment may cause damage to the rear wheel alignment adjustment cams and cause pressure on the 4-wheel steering system. Also the alignment angles will be seriously altered if the tie-rod length is not correct.

1. Disconnect the 4-wheel steering tie rod ends from the trailing arm.
2. Adjust camber and toe-in as described in the service manual. Write down the final readings.
3. Reconnect the 4-wheel steering tie rod ends to the trailing arm.
4. Adjust the tie-rod ends to match the previous toe-in readings.
